# Manhole Inspection Summary

Manhole # S03UU1001MH

Insp Date: **8/1/06 9:53 AM**

**Location** Address: **5900 PARK HEIGHTS AVE**

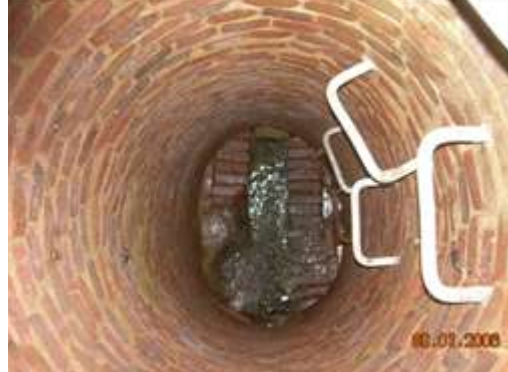
Top View

Corbel and Barrel infiltration. Evidence of surcharge - Bench debris. Channel debris. Corroded steps.

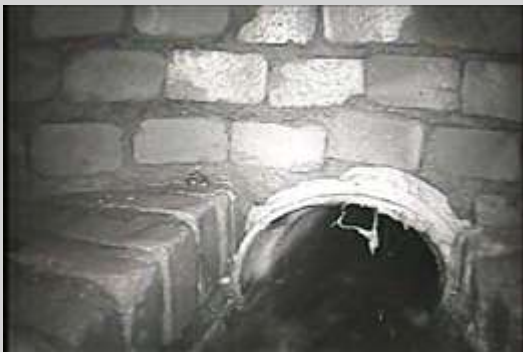
### 8 in. Circular Gravity Sewer Pipe Out @ 12 O'Clock

Pipe Material: **Clay** ☒ Pipe Lined

Invert Depth: **13.10** (ft.) Flow Characteristics: **Fast**

Deposits: ☒ None ☐ Mud ☐ Sludge ☐ Debris ☐ Grease

Infiltration: **None** Pipe Seal Cond: **Unknown**

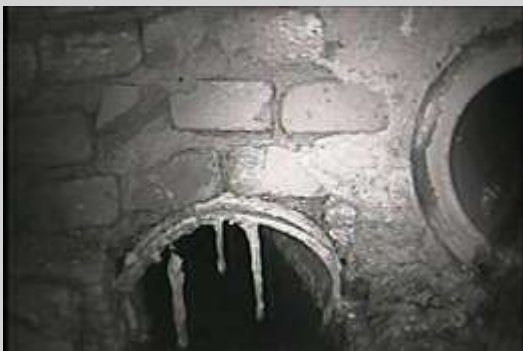
### 8 in. Circular Gravity Sewer Pipe In @ 5 O'Clock

Pipe Material: **Clay** ☒ Pipe Lined

Invert Depth: **13.02** (ft.) Flow Characteristics: **Slow**

Deposits: ☐ None ☐ Mud ☐ Sludge ☒ Debris ☒ Grease

Silt Depth: **0.5** (in.) Deposits Extent: **Light**

Infiltration: **Evidence** Pipe Seal Cond: **Unknown**

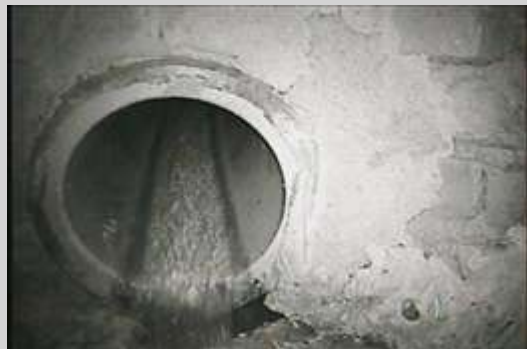
Pipe In @ 7 O'Clock

Pipe Material: **Clay**

Invert Depth: **12.50** (ft.) Flow Characteristics: **Fast**

Infiltration: **Evidence**
